Uniform Mitigation Verification Inspection Form

Inspection Date: 9/5/2018		
Owner Information		
Owner Name: San De Vance Golf and Tennis		Contact Person:
Address: 380 NW 67 Street		Home Phone:
City: Boca Raton	Zip: 33487	Work Phone:
County: Palm Beach		Cell Phone:
Insurance Company:		Policy #:
Year of Home: 1995	# of Stories: 2	Email: ivonne@phoenixfla.com

380 NW 67 Street

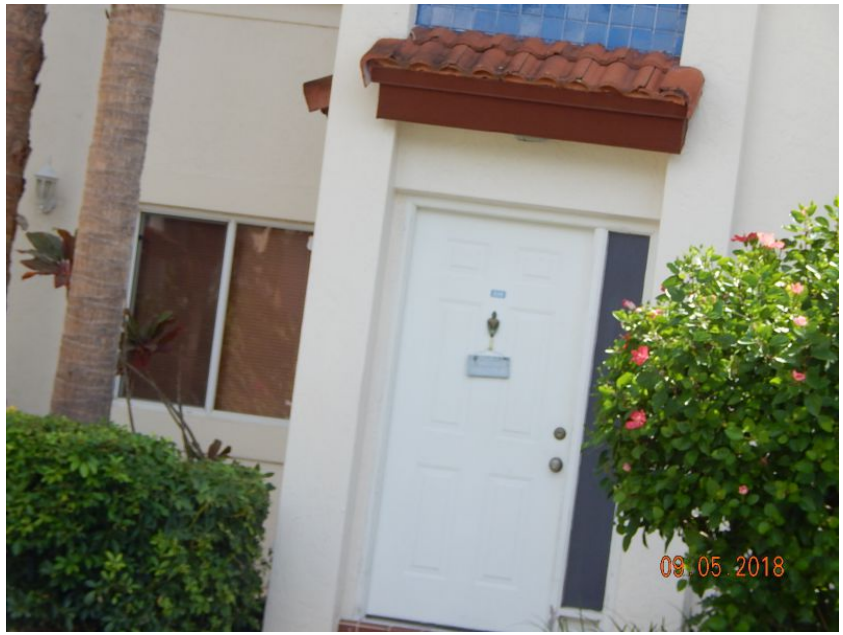
■ **X. None or Some Glazed Openings** One or more Glazed openings classified and Level X in the table above.

Unprotected Window
